T&T Pump Co., Inc.

SERVICE BULLETIN

BULLETIN #TTSB11/51302

REFERENCE: H Series Plumbing

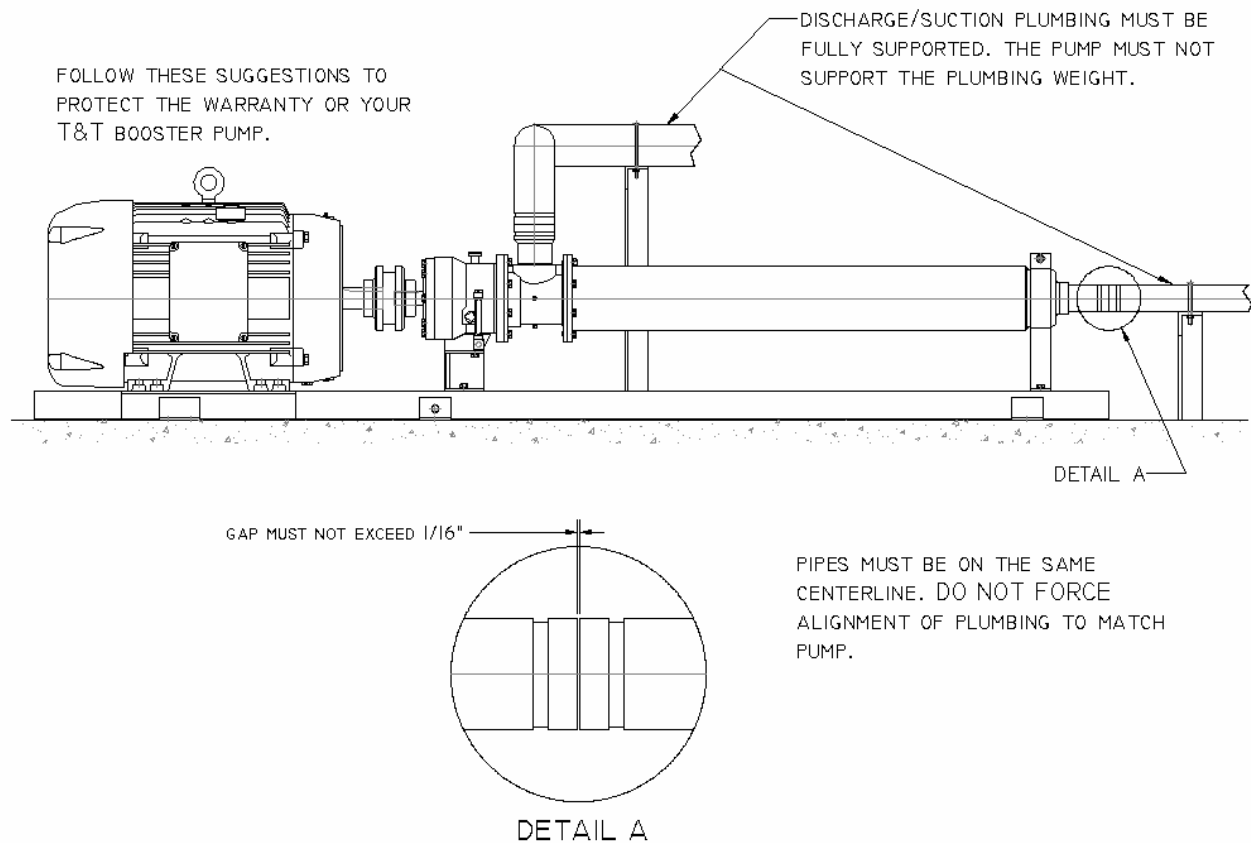
During recent service calls to various customer installations our service technicians have seen systems where the plumbing did not align properly with the pumps inlet and discharge connections. In some cases the plumbing was forced into position putting excessive load on the pump and the pumps mounting feet. In some instances this excessive loading has lead to broken front feet and casing bolt failure. In order to insure warranties, proper installation must be performed. Please review the diagram below.
